INTECH ENGINEERING LTD.
Forensic Analysis • Accident Reconstruction

MOTOR VEHICLE / PEDESTRIAN COLLISION ANALYSIS

RE: Dewar

Date of Incident: November 27, 2016

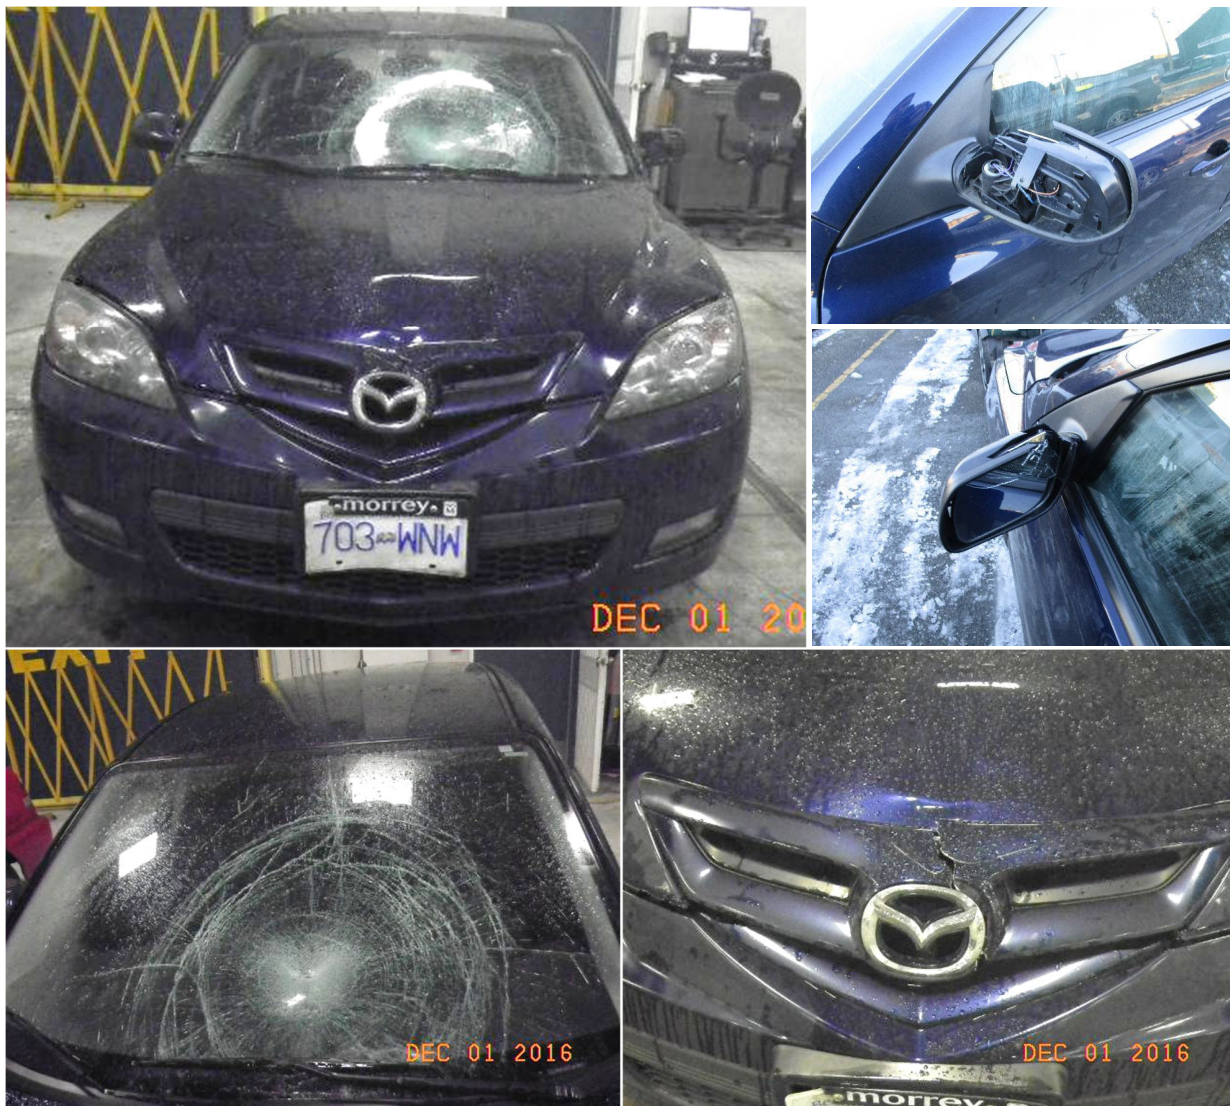
Figure 1: Finnigan Mazda damages.

The Finnigan Mazda was identified as a 2009 Mazda 3 four-door hatchback, with a vehicle identification number of JM1BK343691231789. The ICBC damage estimate indicates that the Finnigan Mazda was equipped with an anti-lock braking system (ABS). The damages sustained to the Finnigan Mazda are illustrated in Figure 1. The visible damages sustained to the Finnigan Mazda included:

- The front license plate was deformed rearward and the license plate frame was cracked along its right side.
- The front center emblem was broken and the grille was fractured.
- The leading edge of the hood was deformed near its centerline.
- The hood was scuffed and deformed downward.
- The windshield was fractured near its base, just to the left of its centerline.
- The left side mirror outer casing was detached and the mirror was fractured.

The Finnigan Mazda damages included bumper, grille, hood and windshield damages. The windshield damage was to the lower middle section of the front windshield. Referencing Expert Autostats [12], the front edge of the hood of the Finnigan Mazda was at an elevation of about 76 cm, while the top of the front bumper was at an elevation of 56 cm. Thus, the effective leading edge of the Finnigan Mazda was likely at an elevation of about 76 cm. Based on assumption #4, Mr. Dewar was about 1.78 meters (5'10") tall; this corresponds to his center of mass being at a height of about 100 cm [13]. Based on the data, Mr. Dewar's center of mass was about 44 cm above the front bumper elevation of the Finnigan Mazda.

The 2002 Toor study [11], provides an approximate guide to correlate the vehicle damage and the approximate range of impact speed. The damage sustained by the Finnigan Mazda correlates to a likely impact speed of about 40 to 50 km/h.

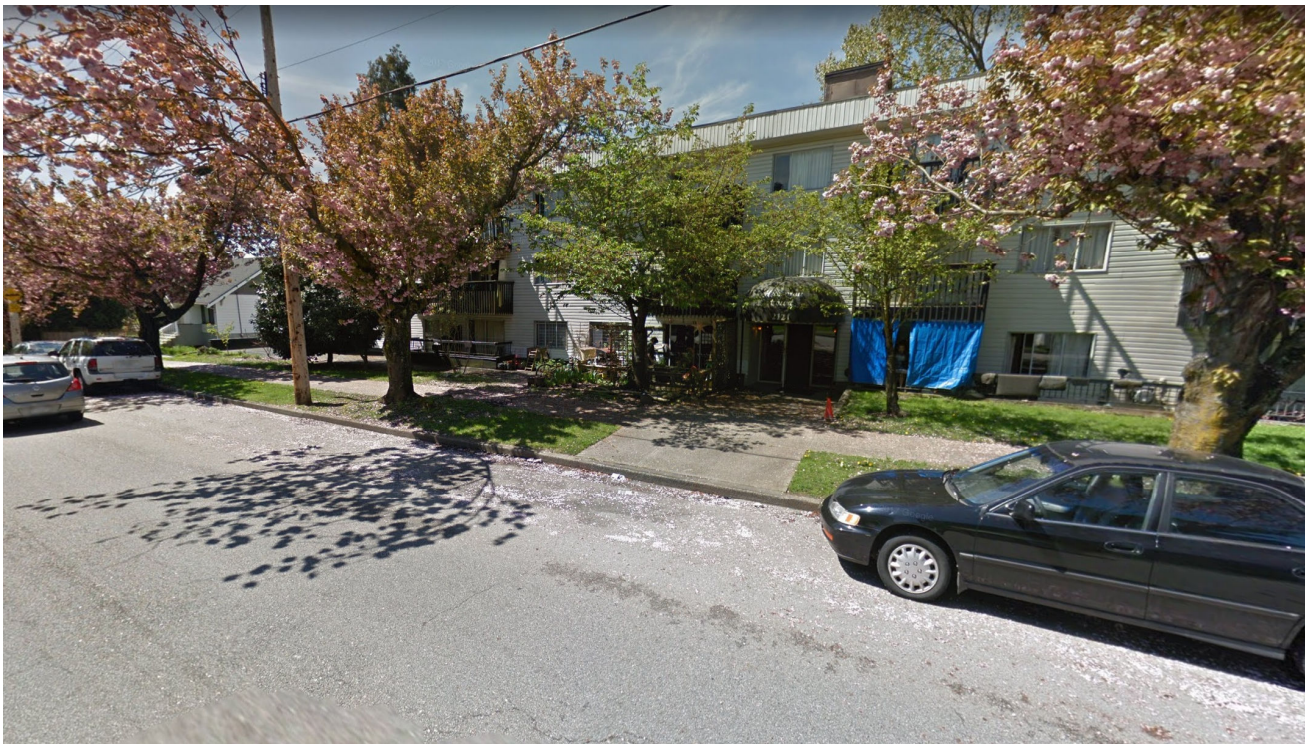
Figure 2: Google Street View image of the entrance/exit of 2121 Wall Street.

There is an apartment building complex at 2121 Wall Street (Hampton Court), with the main entrance/exit approximately 40 meters to the south of Eton Street. The entrance/exit of Hampton Court has a concrete walkway from the entrance/exit region, to the curb edge of Wall Street. The entrance/exit region is shown in Figure 2 as depicted through a Google Street View image from May 2017.

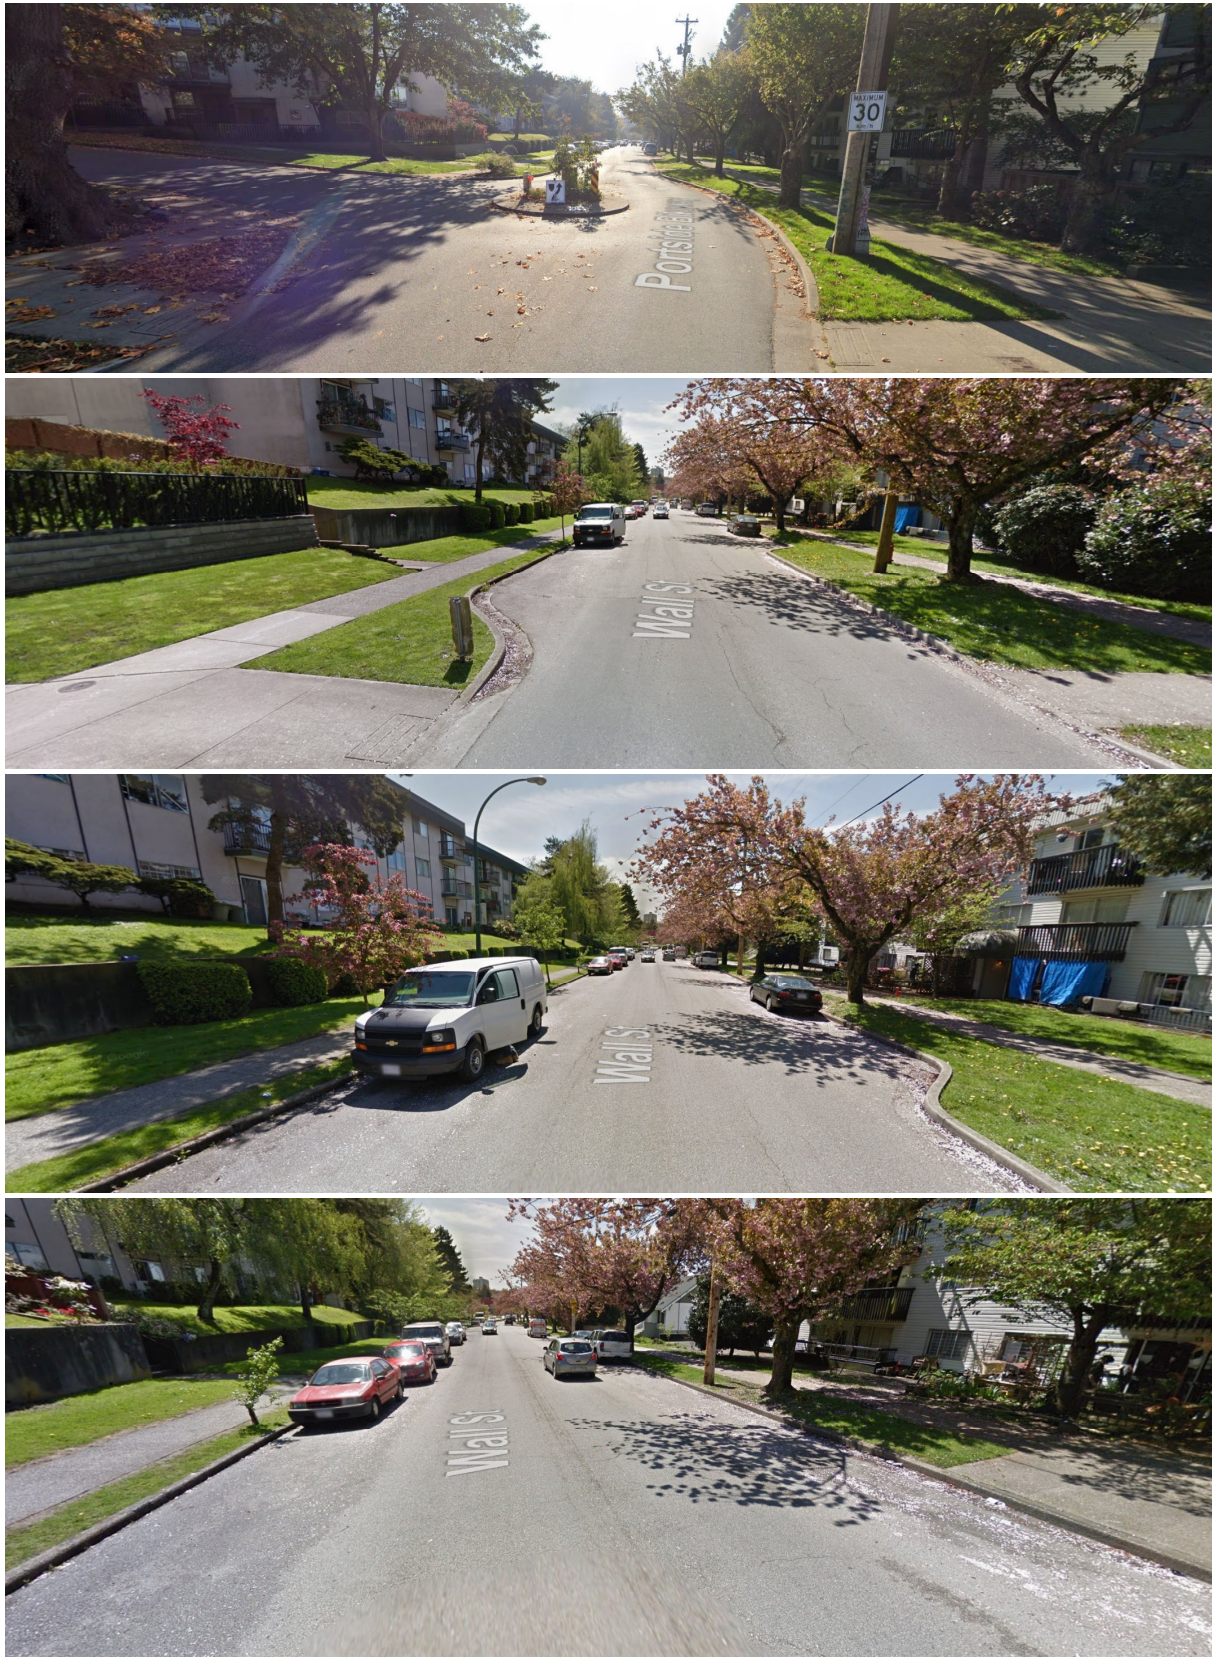
Figure 3: Google Street View images of southbound views along Wall Street.

Figure 3 are images from Google Street View from May 2017, depicting southbound views along Wall Street. Figure 4 illustrates the incident scene geometry, based on aerial imagery from the City of Vancouver; also shown in Figure 4 is an aerial image from 2013.

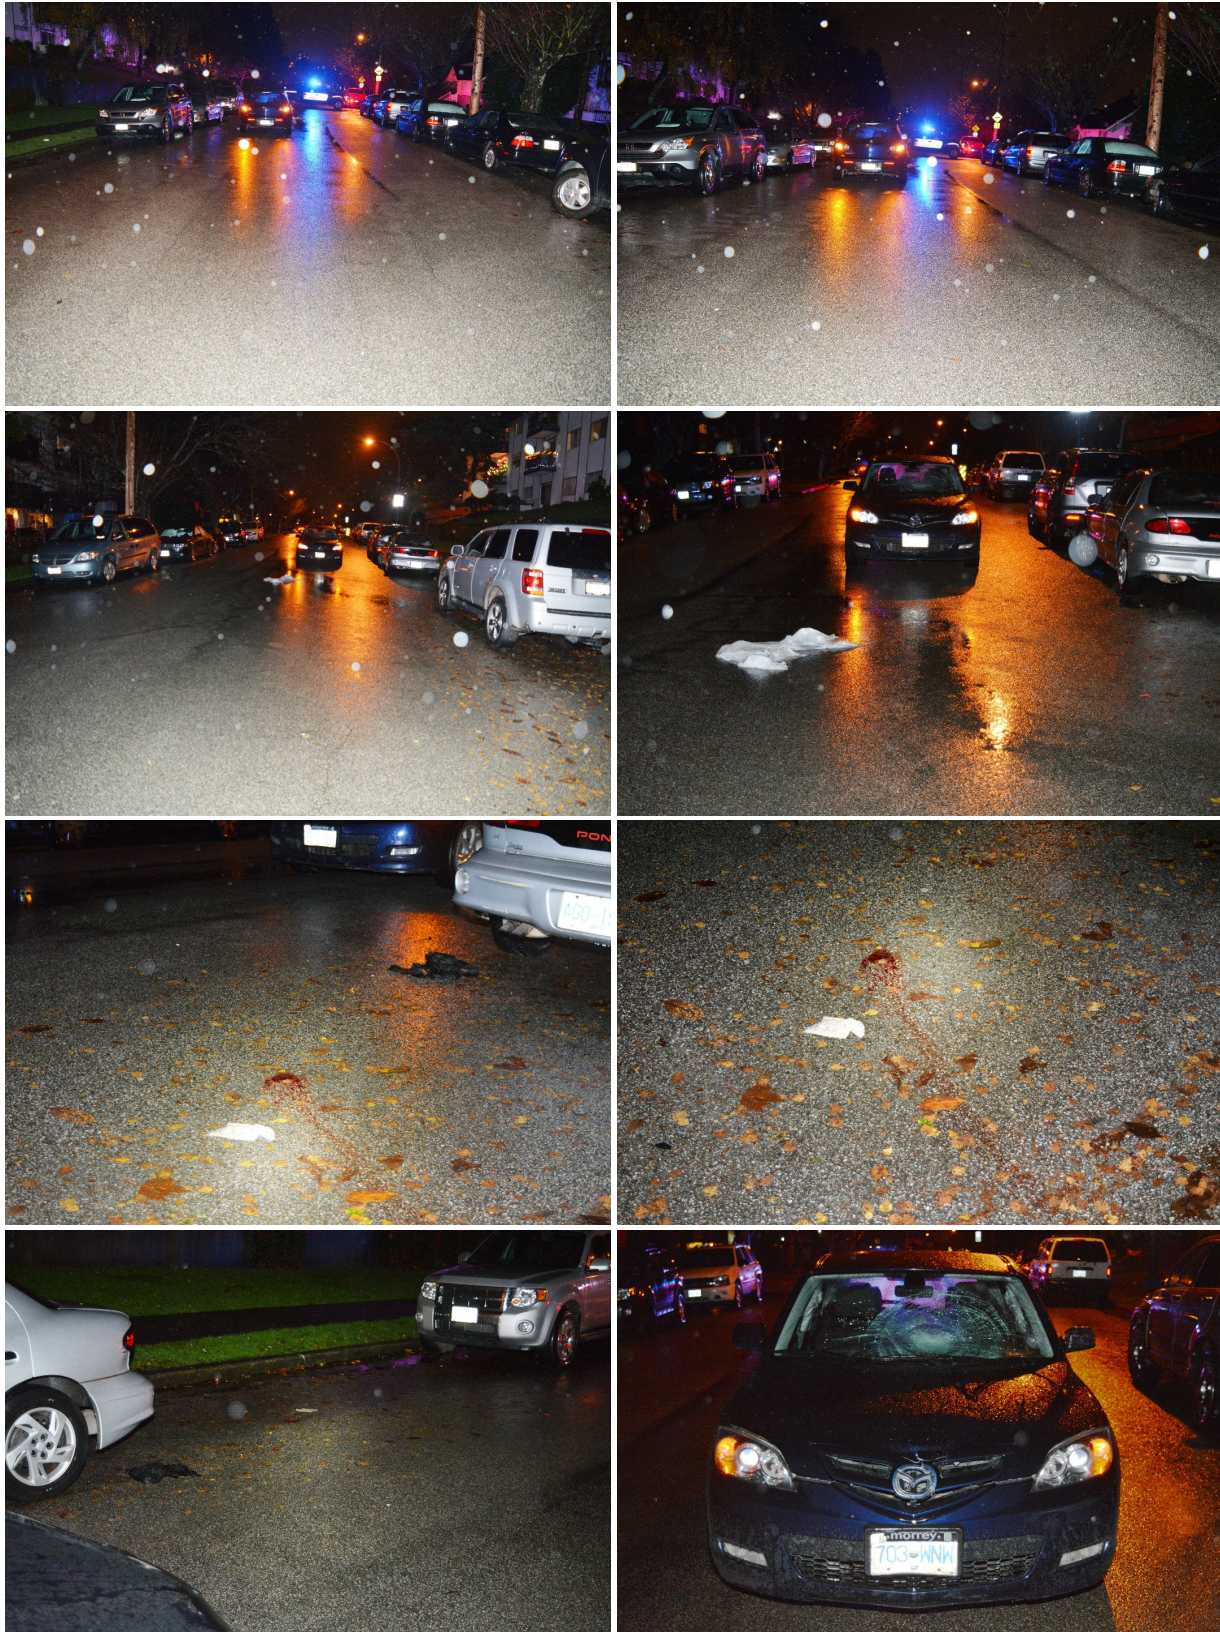
Figure 5: Police scene photographs.

The police scene photographs illustrate the Finnigan Mazda in its post-impact rest position, oriented in a predominantly southbound direction, but angled slightly to the south-east, and biased toward the northbound side of the road. To the south-east (forward and to the left) of the Finnigan Mazda rest position, is a region of red deposits, likely blood. The photographs also show parked cars along both the east and west-side curb edges of Wall Street. The left side mirror casing of the Finnigan Mazda is seen on the asphalt road surface, just forward and to the left of the Finnigan Mazda rest position. Also observed in the police scene photographs is a silver Ford Escape, parked along the east-side curb of Wall Street, to the south of the Finnigan Mazda rest position. Figure 5 illustrates eight of the police scene photographs.
