# Responding Report

Re: Dewar v. Finnigan  
Incident Date: November 27, 2016  
ICBC Claim: AR11340-6  
Your File: 1127574

Report Date: September 11, 2020

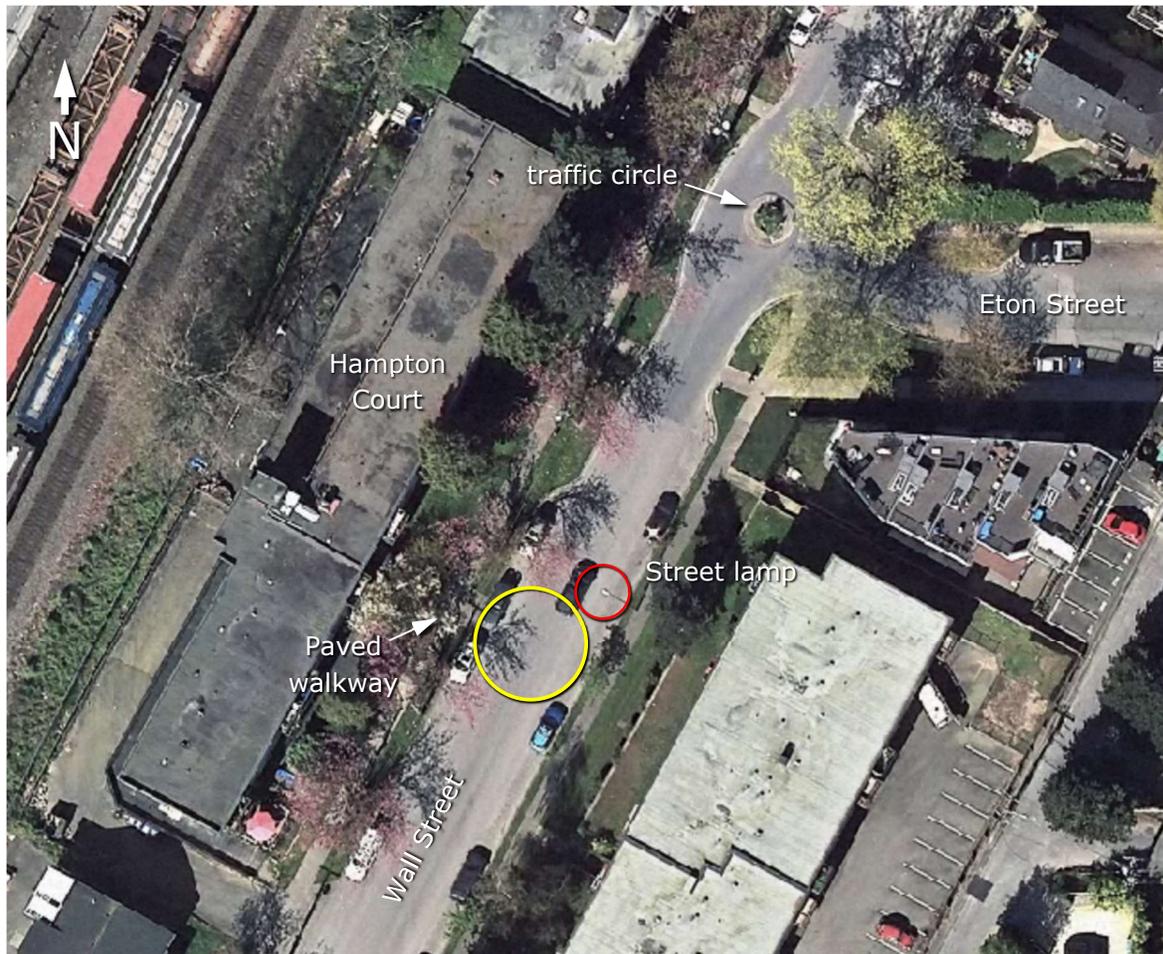
In the 2100 block, Wall Street was a residential road that ran generally north-south (Figure 1). There was a traffic circle at the Eton Street intersection. South of the traffic circle, Wall Street was about 11.6 meters wide, with curbside parking permitted along both sides of the road. Southbound traffic faced a downhill grade of about 1.6%.

Figure 1: Aerial photograph of the incident scene in 2016 (VanMap, 2020). The area of impact is circled in yellow. The nearest street lamp is circled in red.

At the time of the incident, it was fully dark (MEA Forensic, 1995). The only ambient light was from a single street lamp on the opposite side of the apartment complex, which was about 11 meters away from Mr. Dewar's initial position. Therefore, when Mr. Dewar first stepped out from between the parked cars, this street lamp may not have sufficiently illuminated him. Ms. Finnigan would have had to rely substantially on the Mazda's headlights for detection.

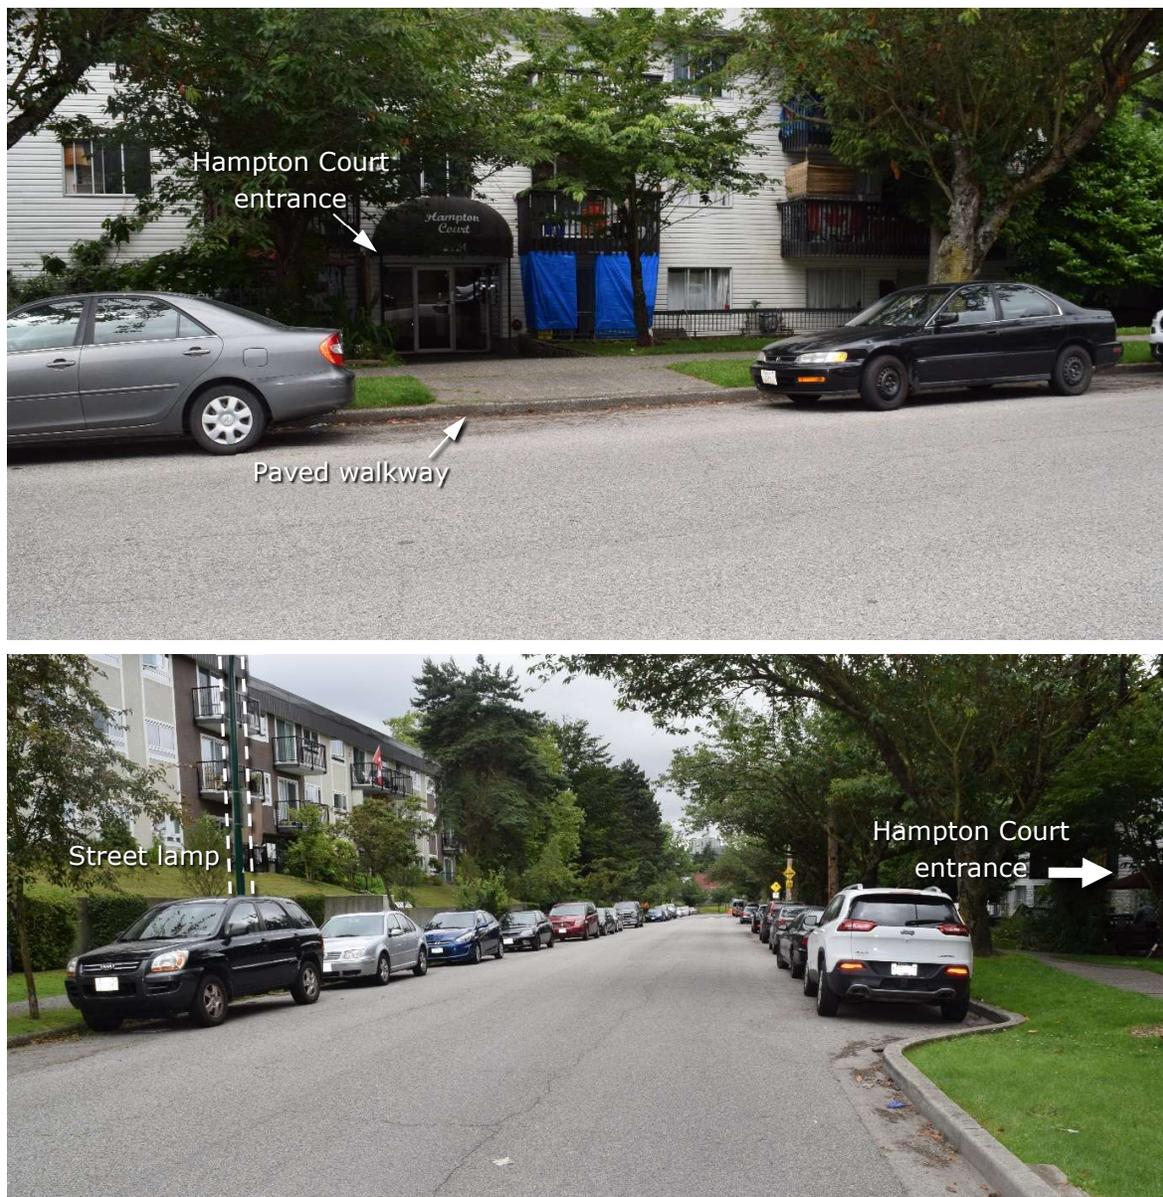
Hampton Court (2121 Wall Street) was an apartment complex on the west side of Wall Street. There was a paved walkway from the entrance to the curb (Figure 2). There were

Figure 2: Photographs taken at Ms. Lee's scene examination. Views shown facing the Hampton Court entrance (top) and facing south from near the traffic circle (bottom).

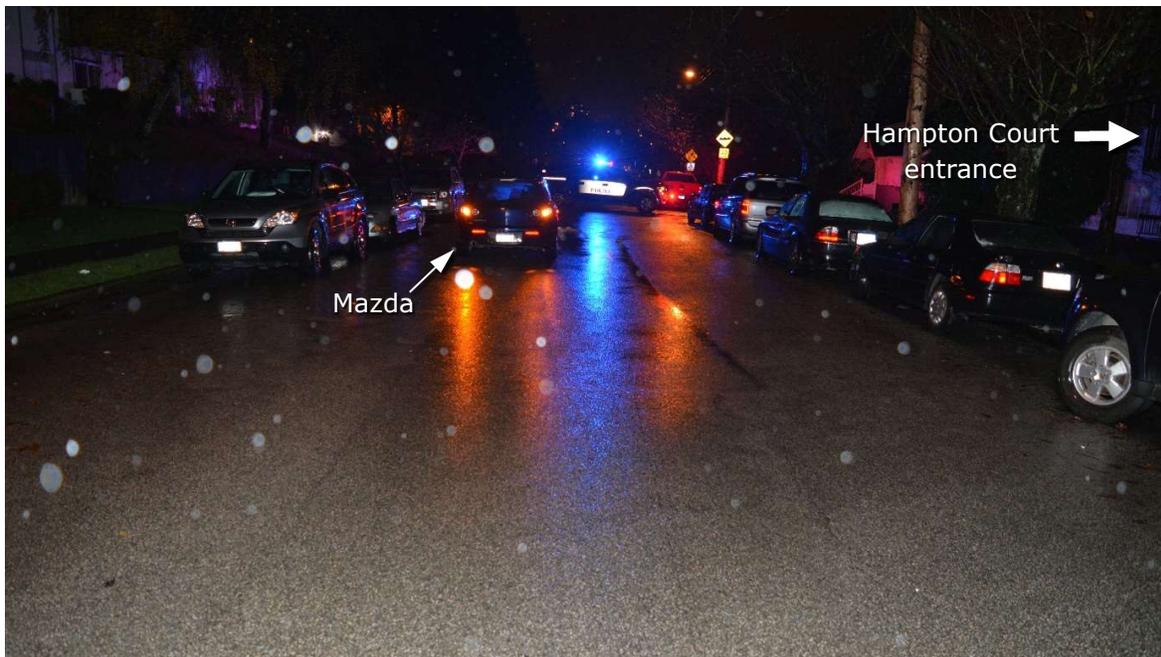
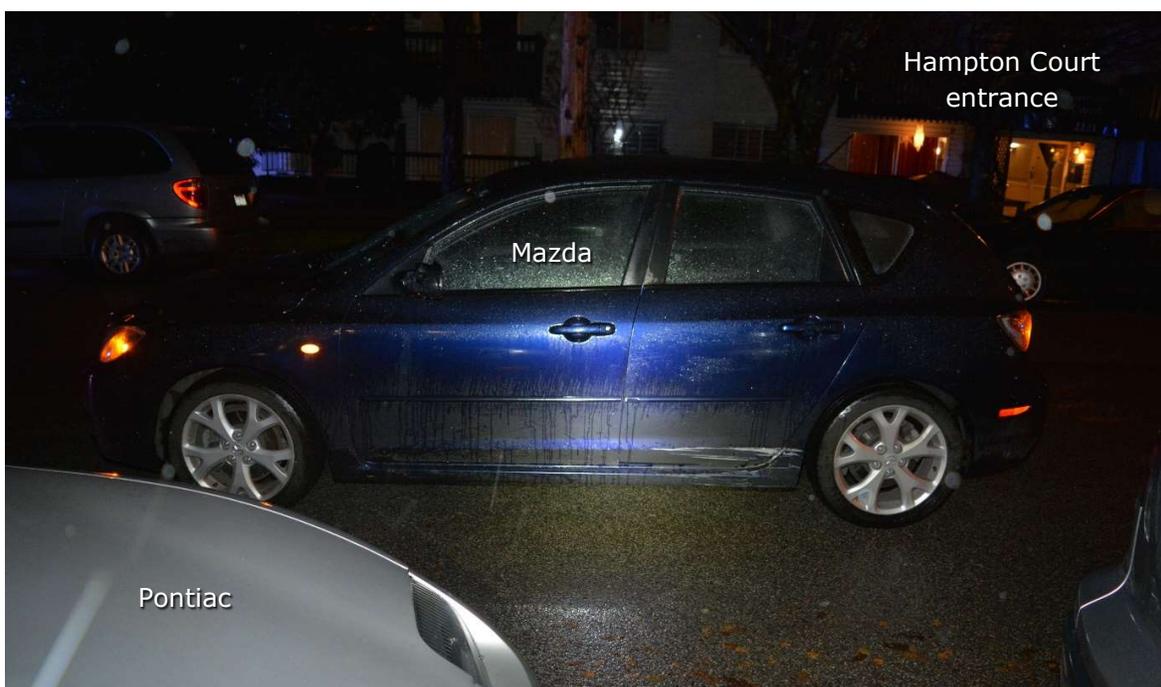
The provided police photographs show the Mazda at rest facing south, south of the Hampton Court entrance (Figure 3). The Mazda appeared to be generally aligned with the road and within the northbound half of the road. Its front wheels were generally straight. Southeast of the Mazda and behind a parked Pontiac was a pool of blood, which I understand was where Mr. Dewar came to rest (Figure 4). A plastic fragment of the Mazda's left rear-view mirror lay next to the Pontiac's driver side door (Figure 5). There were several cars parked along the west curbside of Wall Street, near the Hampton Court

Figure 3: Police photographs showing the Mazda at rest, with views facing south on Wall Street (top) and west from the east curbside (bottom).

Dr. Toor assessed the Mazda's rest position as being, "... in a predominantly southbound direction, but angled slightly to the south-east, and biased toward the northbound side of the road." I agree that the Mazda was within the northbound half of the road with a southbound heading; however, I believe the Mazda's right side was about aligned with the road's centerline and therefore about 0.5 meters west of the position shown in Figure 6 of Dr. Toor's report. I would also emphasize that if the Mazda was angled slightly southeast, it was very minor. The police photographs show that the Mazda was in general alignment with the road and that its front wheels were not notably steered to the left (or right).

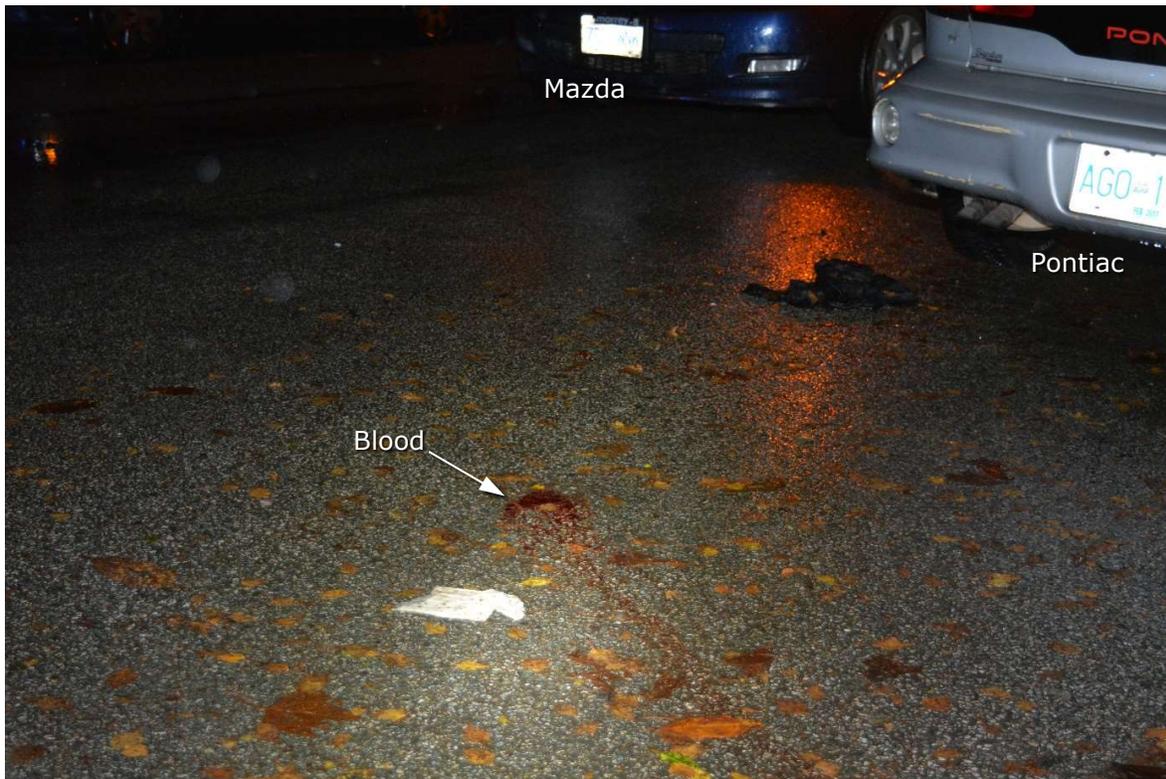
Figure 4: Police photographs showing the Mazda from a northbound-facing view (top) and a closeup of a pool of blood behind a parked Pontiac, southeast of the Mazda (bottom). The top photograph was brightened to show other scene features.

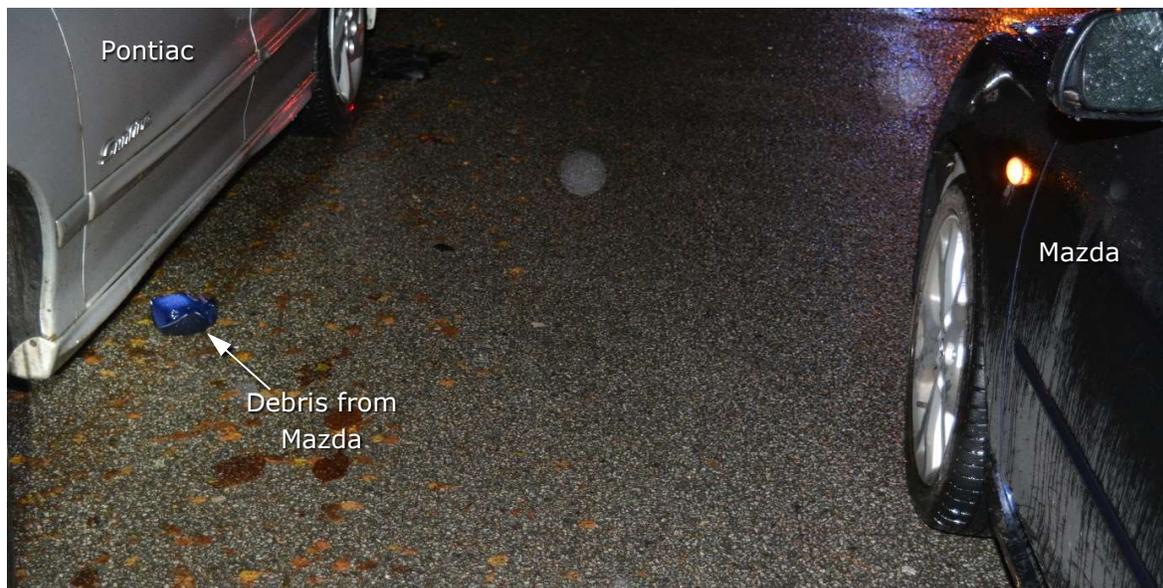
Figure 5: Police photograph showing debris from the Mazda next to the parked Pontiac.

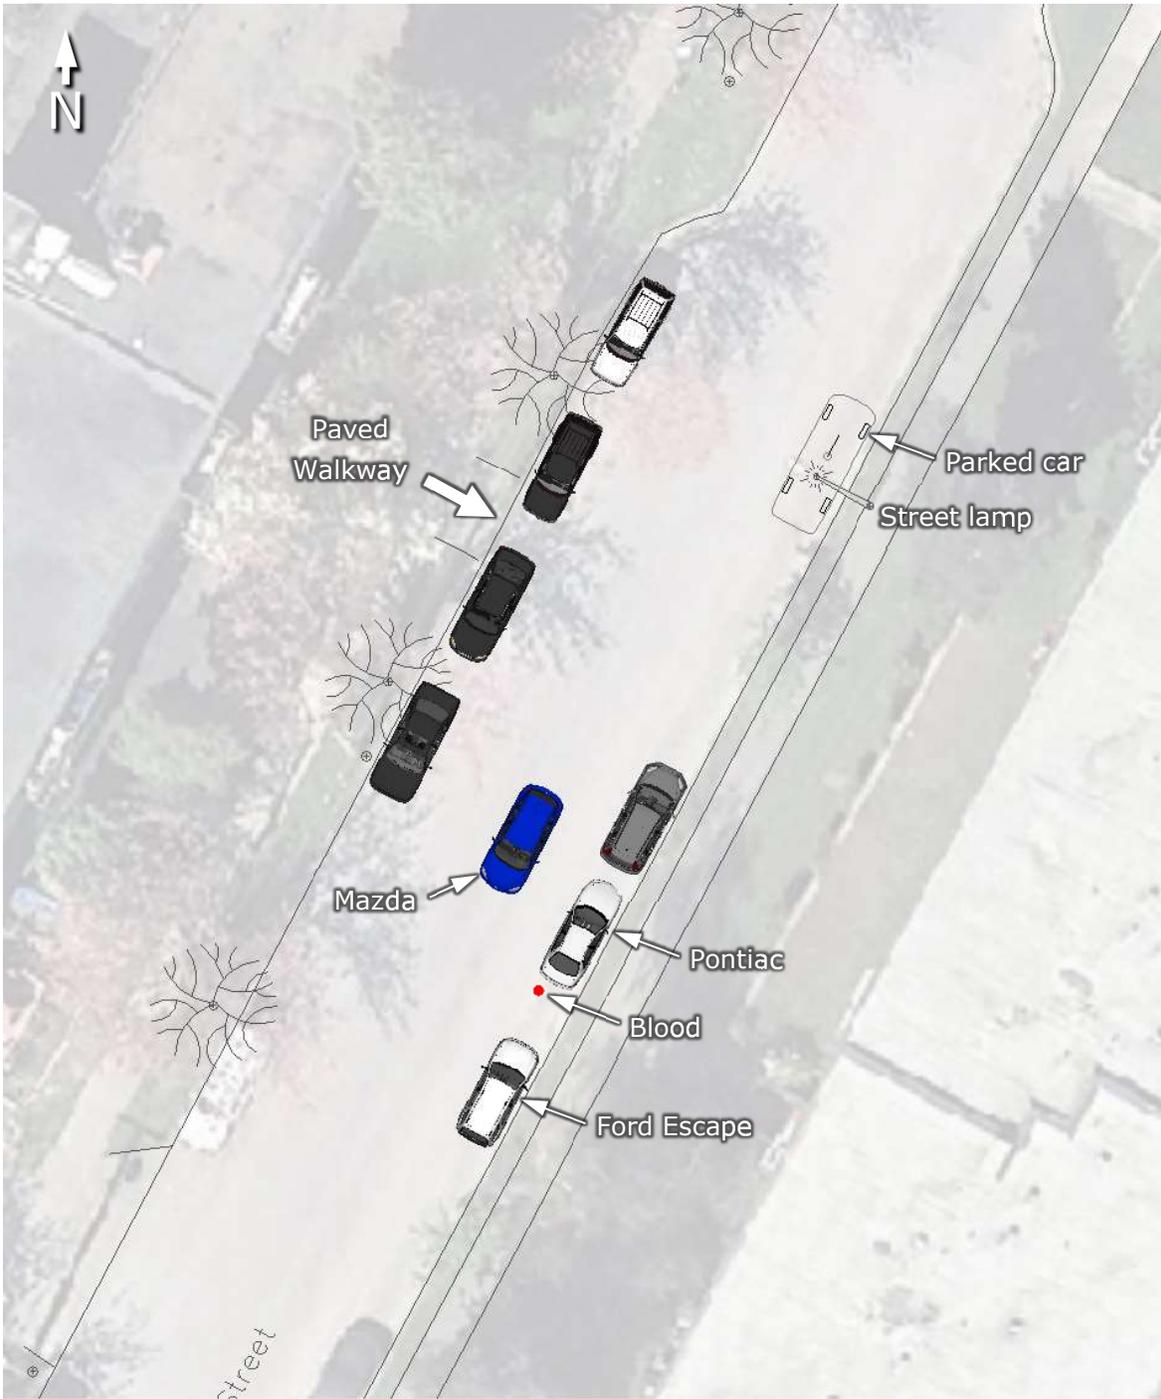
I used the total station measurements and scene photographs to determine the Mazda's rest position and the layout of scene evidence shown in the police photographs (Figure 6).

Figure 6: Estimated rest position of the Mazda and scene evidence, including the approximate positions of nearby parked cars along Wall Street, shown overlaid on a 2016 aerial of the incident area and a drawing based on the total station survey.

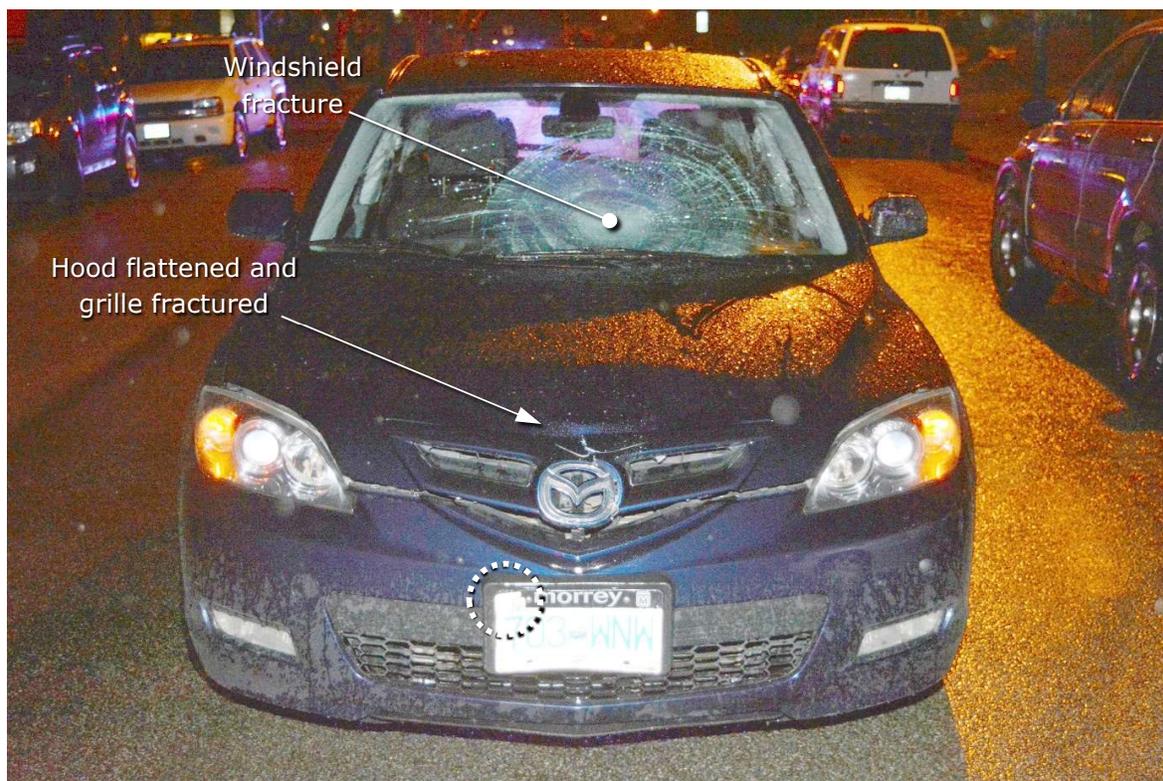
The front center of the hood was flattened and the grille was fractured directly in front of this hood damage (Figure 7). The hood appeared to be misaligned with the front headlights. The lower part of the windshield was fractured just left of the vehicle's centerline. The front license plate bracket was fractured on the right side and the license plate was bent in.

Figure 7: Mazda 3 damage. The front license plate bracket was fractured where circled. This image was brightened for clarity.

The ICBC repair estimate specified replacement of the front grille, license plate frame, hood assembly, windshield and left rear-view mirror and repairs to the front bumper cover. The repair estimate also noted that the damage to the left rear door area was unrelated to this incident.

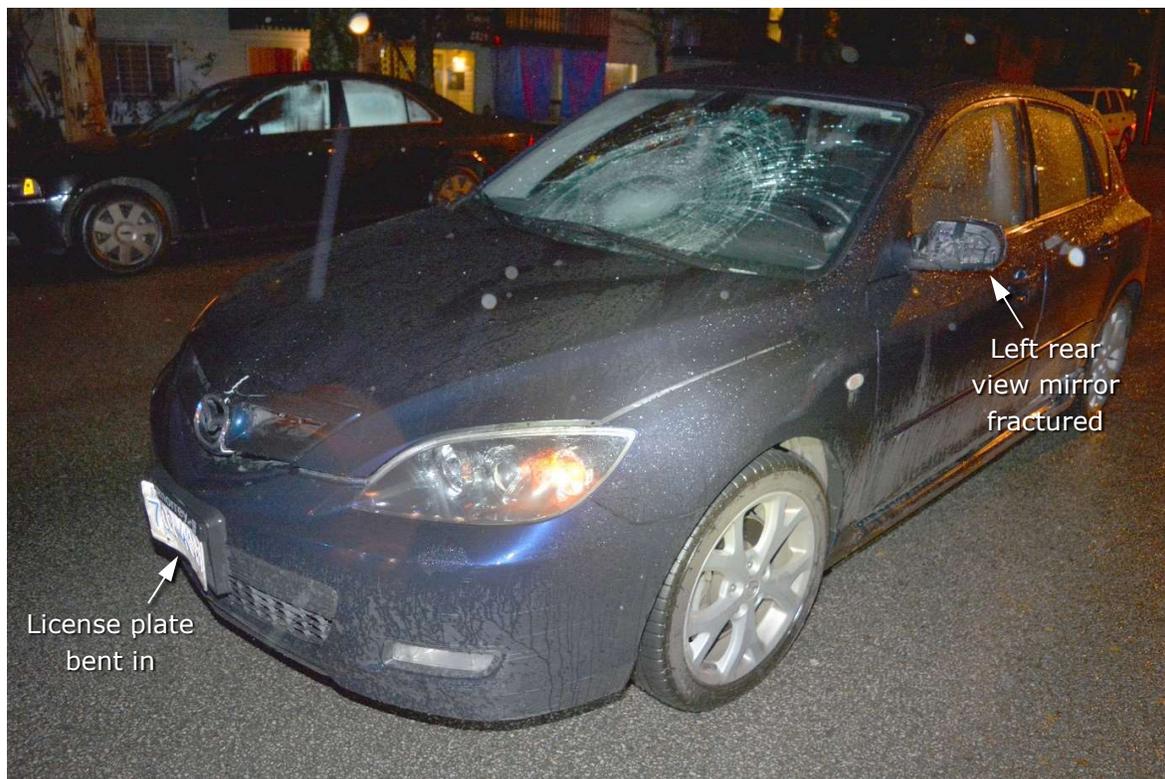
The left rear-view mirror's plastic housing was fractured, with pieces missing (Figure 8).

Figure 8: View from the left front.

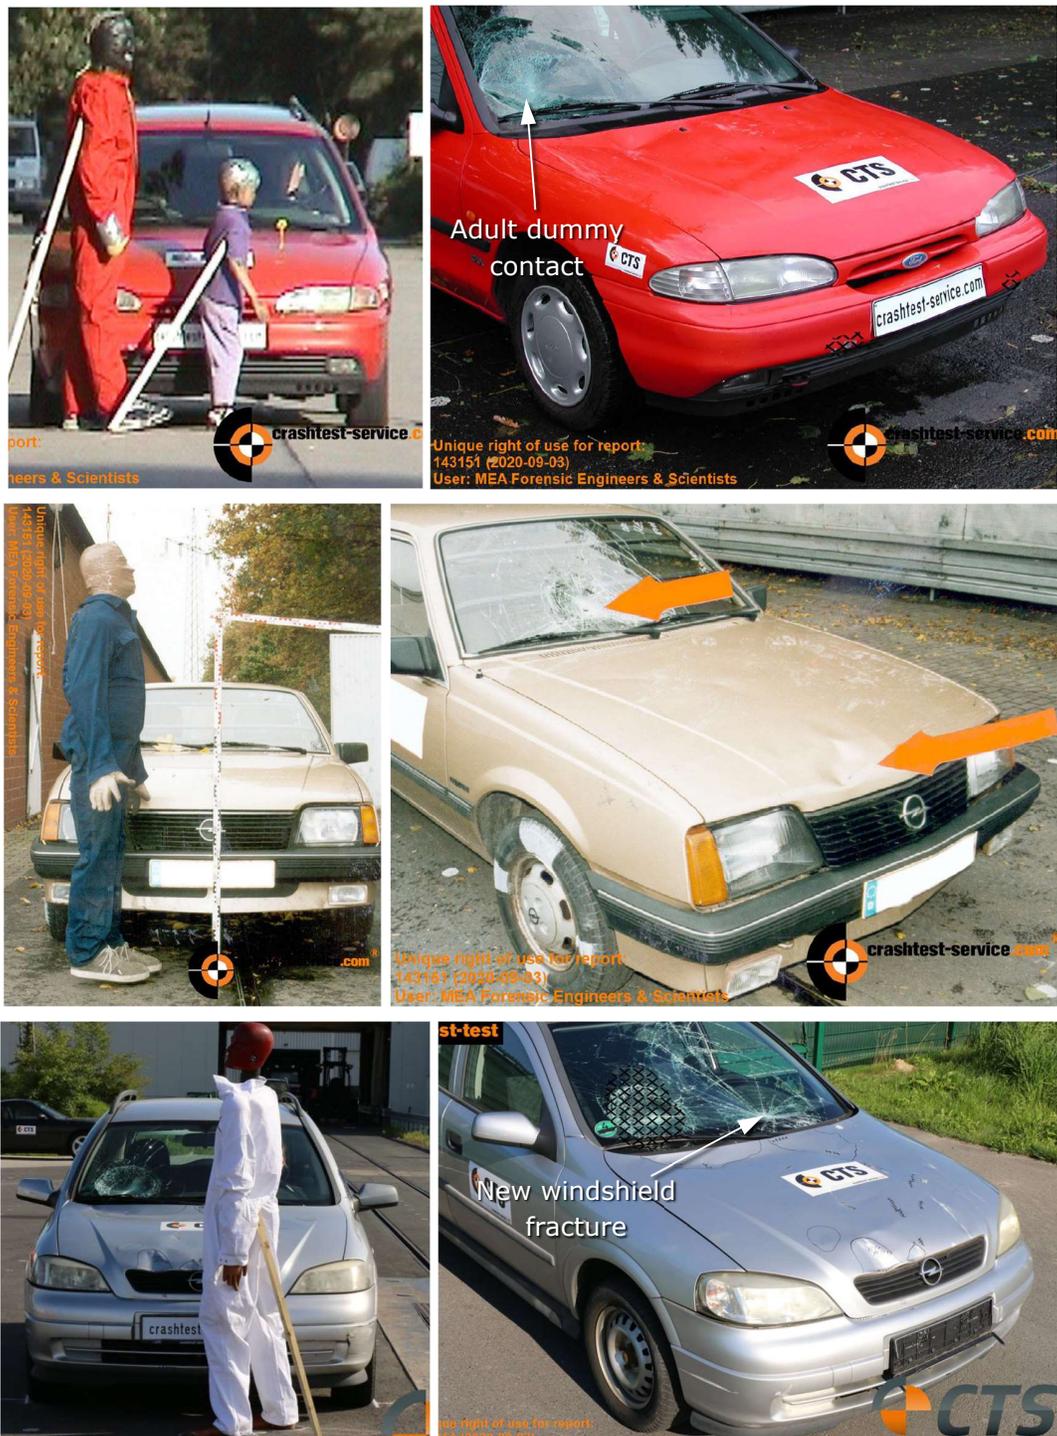
I reviewed staged collisions by Crash Test Service (1998, 2004, 2015), in which the front of small passenger vehicles, with similar front profiles as the Mazda, struck the side of stationary pedestrian dummies in a similar orientation to the impact with Mr. Dewar. At impact speeds of as low as 30 km/h, the striking cars sustained similar damage to the Mazda; that is, front bumper cover damage, flattening of the hood, and a windshield fracture (Figure 9). In these tests, the adult pedestrian dummies had heights between 1.72 and 1.81 meters and were struck by cars with front bumper heights between 0.54 and 0.58 meters. The dummies' corresponding center of mass heights were between 0.96 and 1.01 meters, based on using the same center of mass reference that Dr. Toor used in his report. Similar to Dr. Toor's calculation of Mr. Dewar's center of mass being about 0.44 meters above the front bumper of the Mazda, the dummies in these staged collisions had a center of mass that was above the striking car's front bumper by between 0.40 and 0.46 meters. Therefore, based on the Mazda damage alone, a lower impact speed of about 30 km/h was possible.

Figure 9: Staged collisions resulting in similar vehicle damage as Ms. Finnigan's Mazda, at impact speeds of 30 km/h by the Ford Mondeo (top row) and Opel sedan (middle row) and 34 km/h by the Opel Astra (bottom row). Impact orientation is shown on the left and post impact damage on the right. Pre-existing damage is shown by black hatch marks.

Dr. Toor summarized his analysis by concluding that the Mazda's speed was probably about 46 km/h. As discussed above, the speed ranges presented in each of his methods are too narrow. Based on the literature, staged collisions, and calculations discussed above, I find that it was possible for the Mazda to have been travelling at as low a speed as 35 km/h at impact.
